Manhole Inspection Summary

Manhole # S05WW1023MH

Insp Date: **9/13/06 7:52 AM**

Location Address: **5802 BLAND AVE**

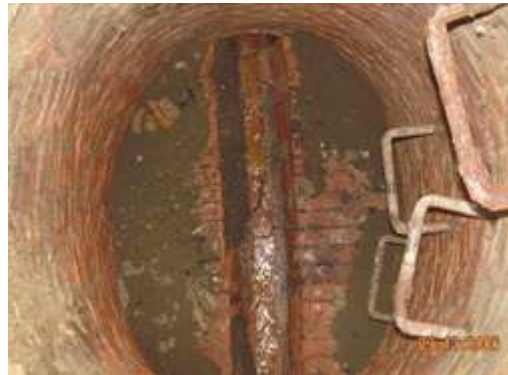
Top View

Evidence of surcharge - Bench debris.
Corroded steps.

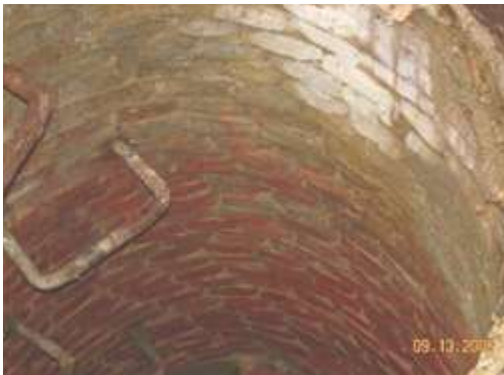
Defect

Adjustment and Corbel infiltration.

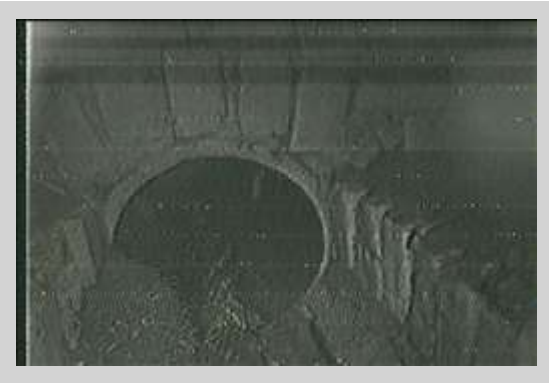
8 in. Circular Gravity Sewer Pipe Out @ 12 O'Clock

Barrel deterioration and infiltration. Channel root intrusion.

Infiltration: **Evidence** Pipe Seal Cond: **Roots**

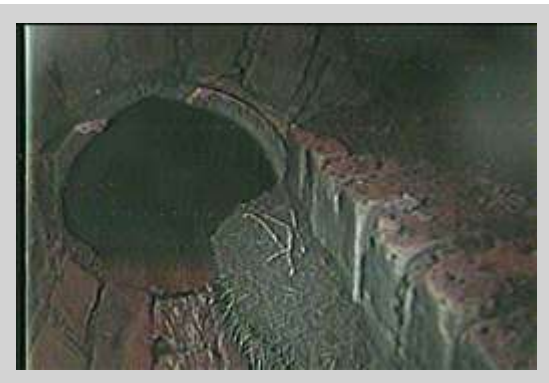
8 in. Circular Gravity Sewer Pipe In @ 6 O'Clock

Barrel deterioration and infiltration. Channel deterioration and root intrusion.

Infiltration: **Evidence** Pipe Seal Cond: **Roots**
